# Manhole Inspection Summary

Manhole # S15QQ1024MH

Insp Date: **11/20/06 10:05 AM**

**Location** Address: **2518 OAKLEY AVE**

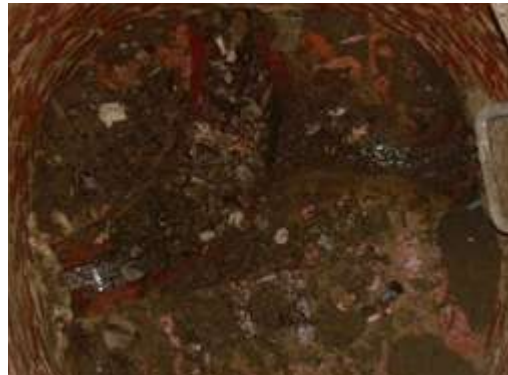
Top View

Evidence of surcharge - Bench debris.  
Channel debris.

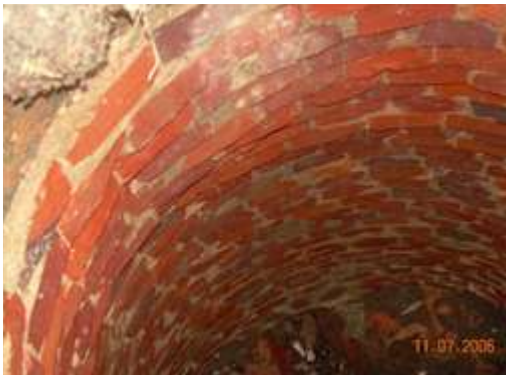
Defect

Adjustment, Corbel and Barrel infiltration.

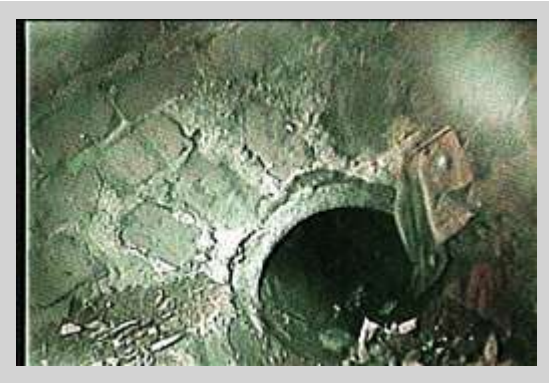
### 8 in. Circular Gravity Sewer Pipe Out @ 12 O'Clock

Barrel deterioration and infiltration.

Infiltration: **Evidence** Pipe Seal Cond: **Cracked**

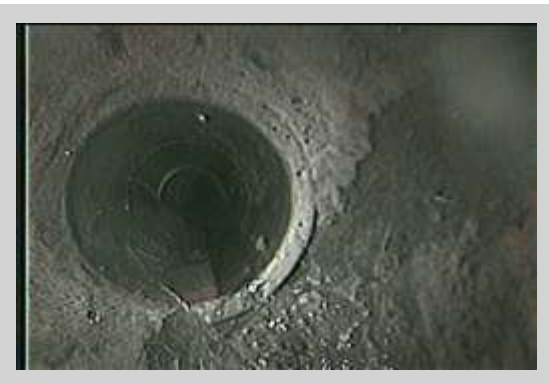
### 6 in. Circular Gravity Sewer Pipe In @ 3 O'Clock

Channel root intrusion.

Infiltration: **Evidence** Pipe Seal Cond: **Roots**

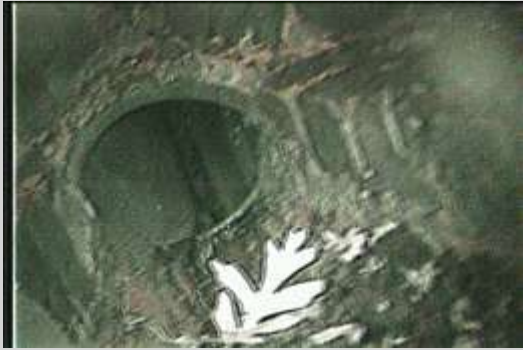
6 in. Circular Gravity Sewer

Infiltration: **Evidence**

Pipe Seal Cond: **Cracked**
